WOHL COATINGS INC. ShurBond 500 Repair Kit

CASE HISTORY:

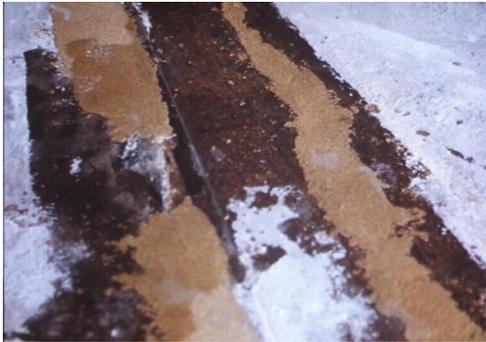
The photo shows a close up of the steel rail cover by ShurBond 500. The photo on the right shows one of the rail lines after smoothing with ShurBond 500. The area to the left shows concrete failure areas that have been repaired with ShurBond 500.

We recommended that the steel rails be left in place and that ShurBond 500 be used to fill in the large dips and voids next to the steel rails and the existing concrete.

The result was a smooth floor that provided a no shock fork truck traverse either perpendicular or along the length of the rail. In service five years with NO loss of bond or performance of ShurBond 500. Only minimal surface preparation was used. High pressure wash with TSP solution to remove excess oil and then a clear high pressure rinse. Surface was allowed to dry prior to coating.
