Wohl Coatings Inc.
Applied Industrial High Performance Grade Epoxy Coatings
For Repair and Provide New Chemical Resistance Surface

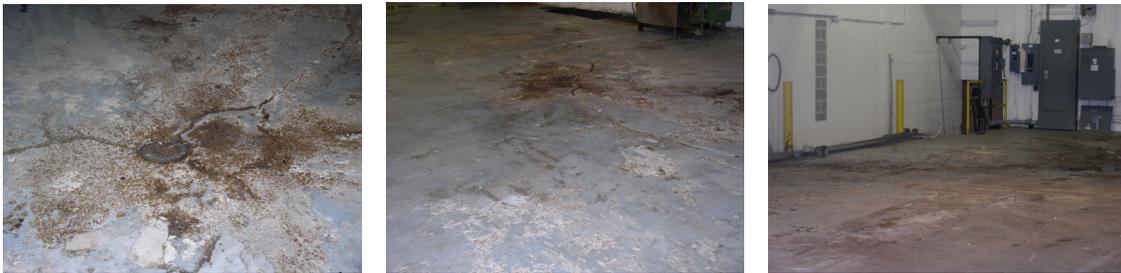
The best way to describe these type of application is by using an actual case history. Condition: Some 4000 square feet of concrete was severely corroded by an process that used an organic acid which etched 75% of the concrete from ¼” to 2” in depth. In other areas the existing coating had been loosened and was delaminating from the concrete. The floor was not usable by the next tenant and had to be repaired. The customer choose to repair and resurface rather than full replacement because of the lower cost and the short length of time to make the application compared to tear out and replacement of the floor.

Drain area eaten away- 2nd Drain also destroyed- General Floor area deeply etched
Repair Procedure:

- Step One: Prepare the surface. The concrete surface was cleaned to be free of all oil and grease and all loose coating . The surface was power cleaned and washed with TSP solution to remove the oil and grease. In this case the old coating was sanded and ground with diamond tools to insure all loose coating was removed from the surface. The surface was again treated and power washed with TSP to further neutralize any acid.

- Step Two: The cleaned surface was allowed to dry and become completely free of surface water before proceeding.
- Step Three: WOHL ShurBond 500 is a 100% solids epoxy coating which can be filled with ground silica to form a trowel able grout. This grout was hand troweled into the deepest of the acid corrosion areas to bring those areas up to level grade with the non-corroded concrete. This material was allowed to cure overnight and provide a base for the color application.

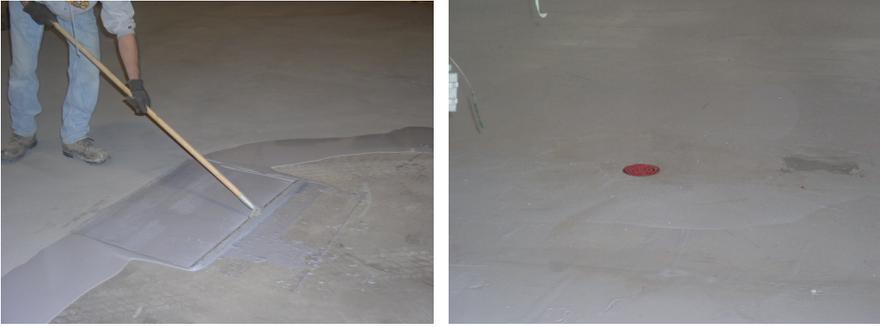
Application of ShurBond 550 coating to surface. Details of newly finished drain.

- Step Four: WOHL ShurBond 550 Medium Gray coating was applied over the entire 4000 sq.ft. Crystal White Silica was broadcast over the wet epoxy surface and allowed to cure overnight.

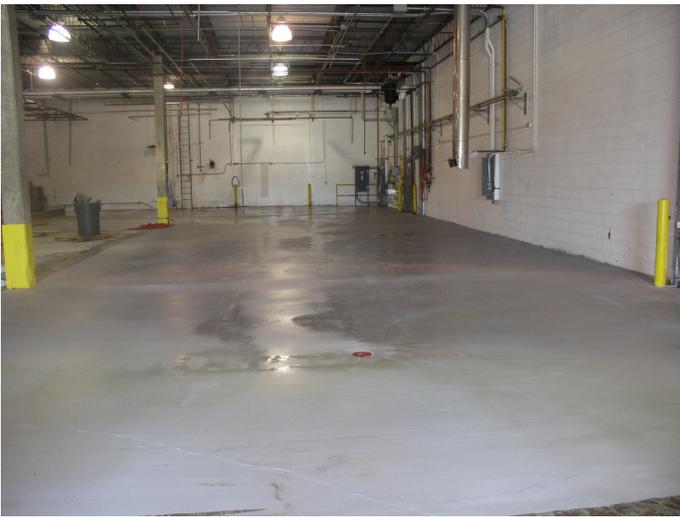
Finished floor.

- Step Five: The next day the excess crystal silica was removed and the job was complete. Total time to recover and recoat the surface was 4 working days using 2 workers. At this point the customer could have requested the application of a topcoat for easier cleaning. However the customer choose to keep the anti-slip surface because of the normally wet working area in the liquid detergent packaging line.

- Step Six: 24 hours later the surface was returned to full service including fork truck traffic, pallets and installation of heavy equipment.
